THE APOLLO 13 ACCIDENT

HEARINGS
BEFORE THE
COMMITTEE ON
SCIENCE AND ASTRONAUTICS
U.S. HOUSE OF REPRESENTATIVES
NINETY-FIRST CONGRESS
SECOND SESSION

JUNE 16, 1970

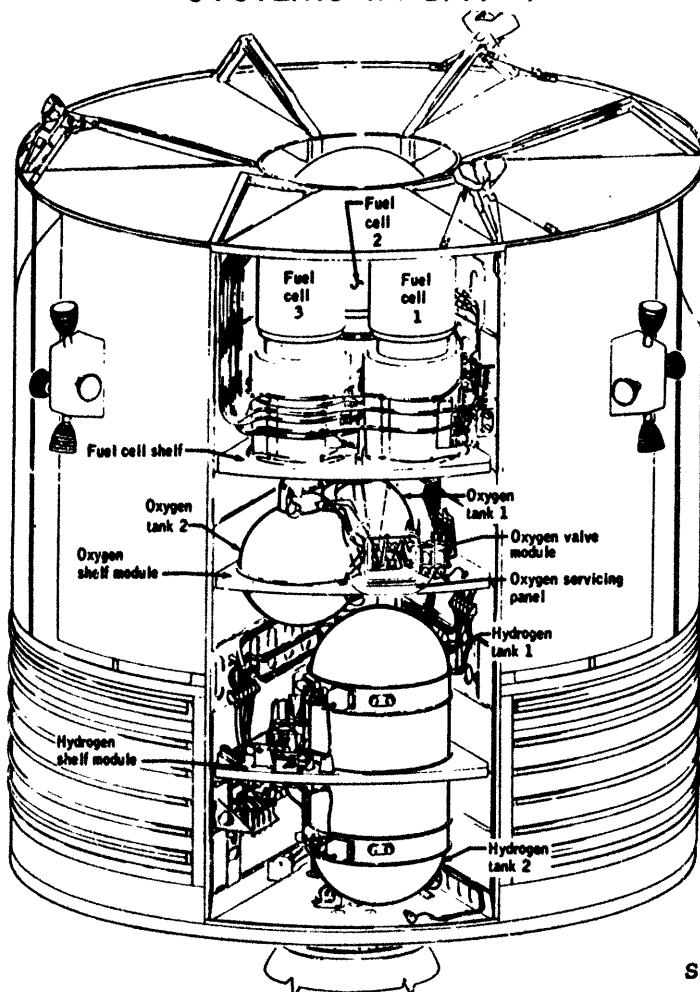
These are two hydrogen tanks with a cylindrical sleeve to fasten them together. The two oxygen tanks sit on this shelf. Oxygen tank 1 is here, and No. 2 is here [indicating]. There is a valve module and servicing panel here. This oxygen tank No. 2 is the one which failed.

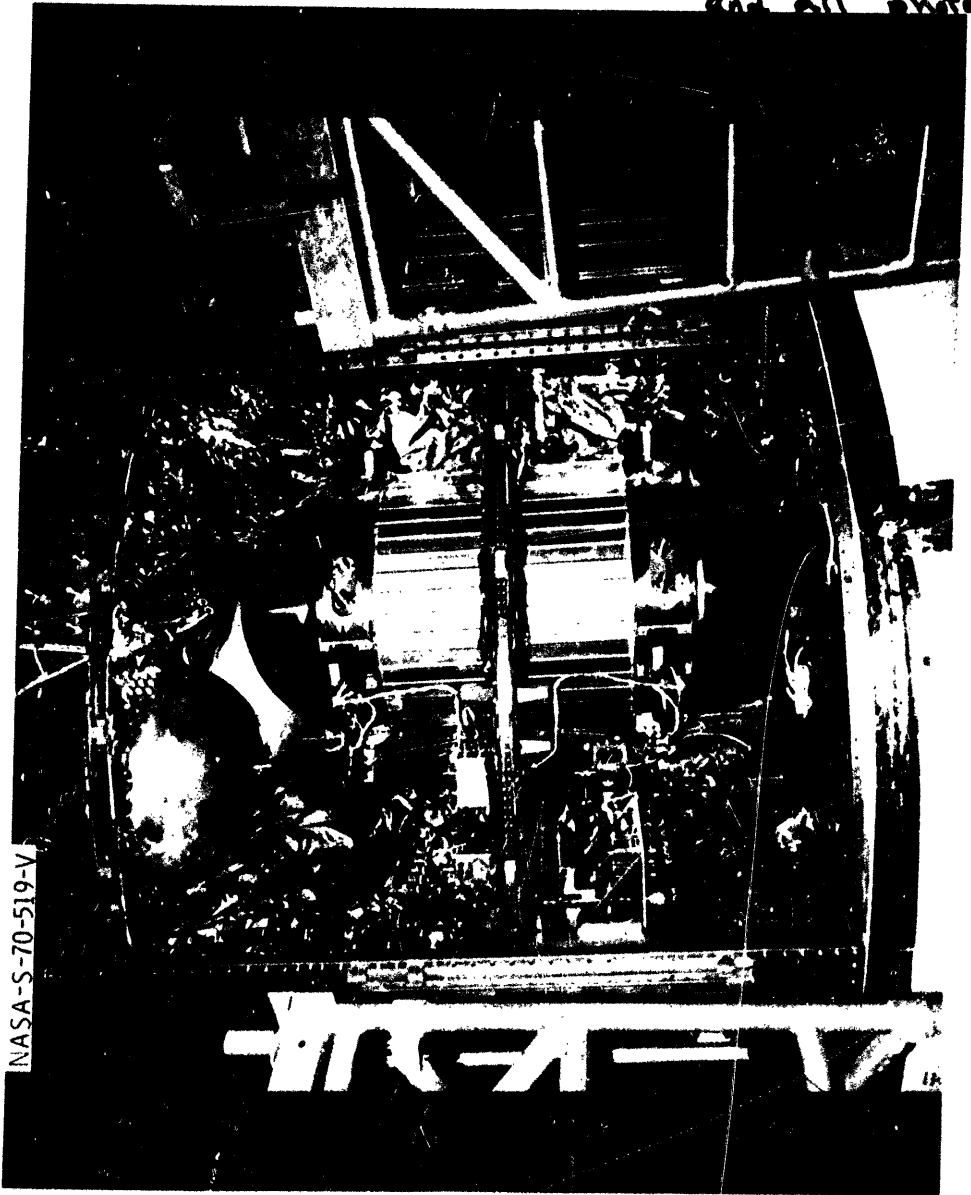
Slide 5

This is the lower section of bay 4 showing the hydrogen tanks and the bottom of oxygen tank 2 which failed. All this crinkly material which looks a little messy, is designed that way. It is a Kapton-coated Mylar insulation.

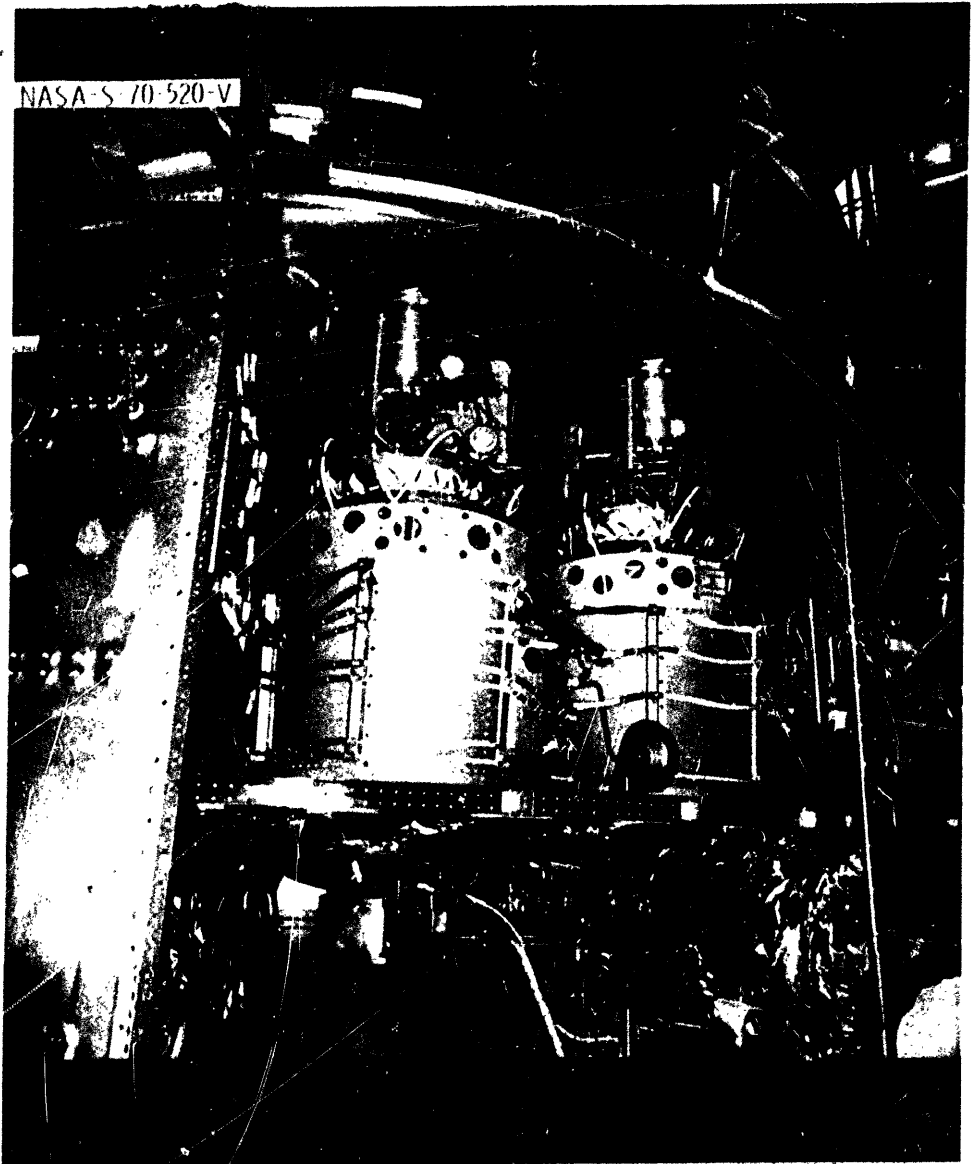
Slide 6

On the right (slide 6) are shown two of the three fuel cells which are on the shelf above the oxygen tanks. This is oxygen tank No. 2 that failed. This is the dome of the tank which covers the spiraling tubes which penetrate the tank and which carry fluid into and out of the tank as well as the electrical wiring.

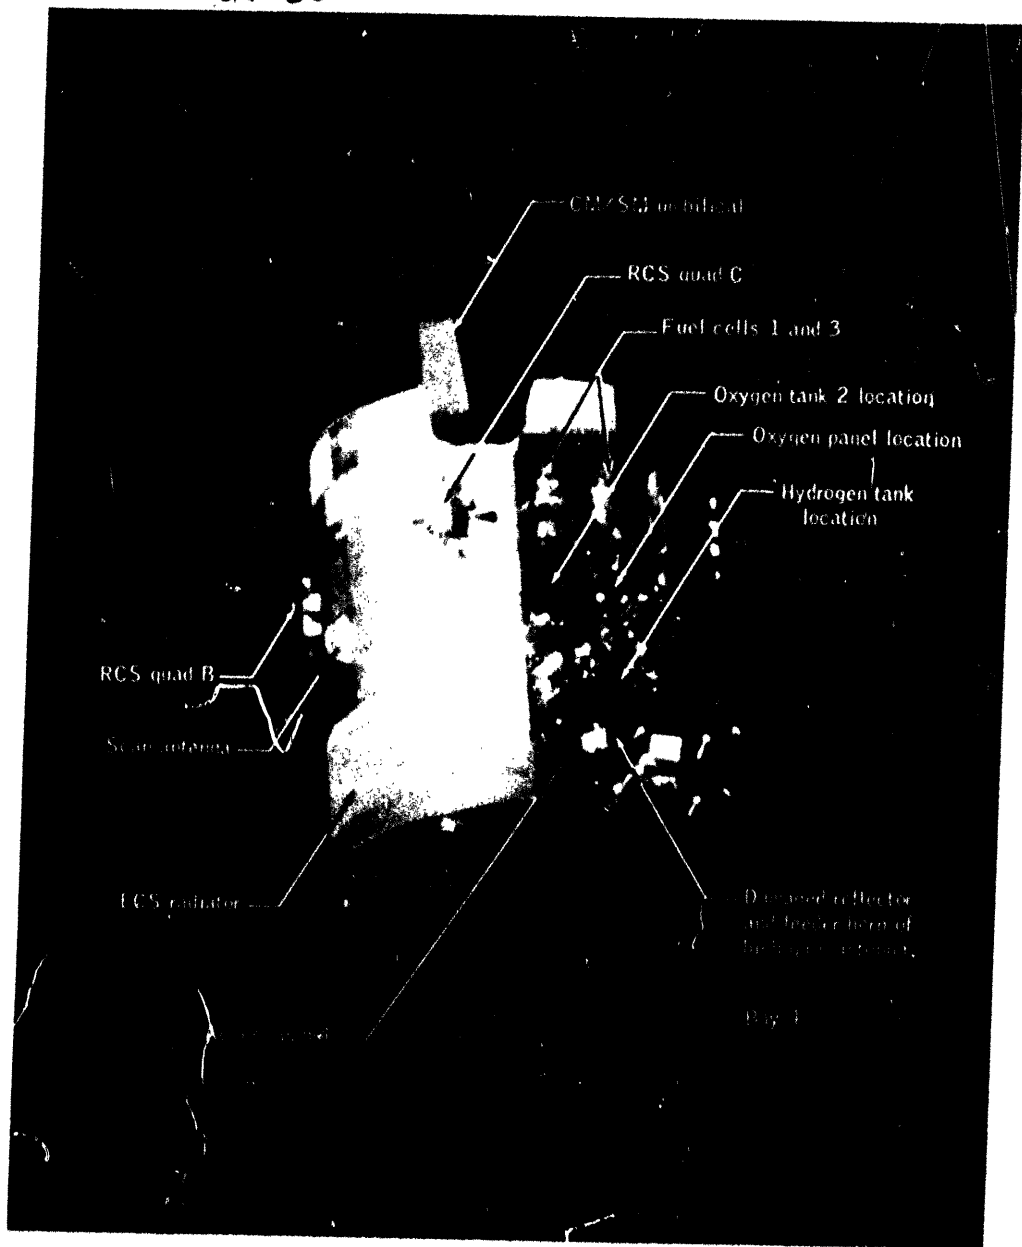
Inflight photograph of service module showing damage to bay 4.

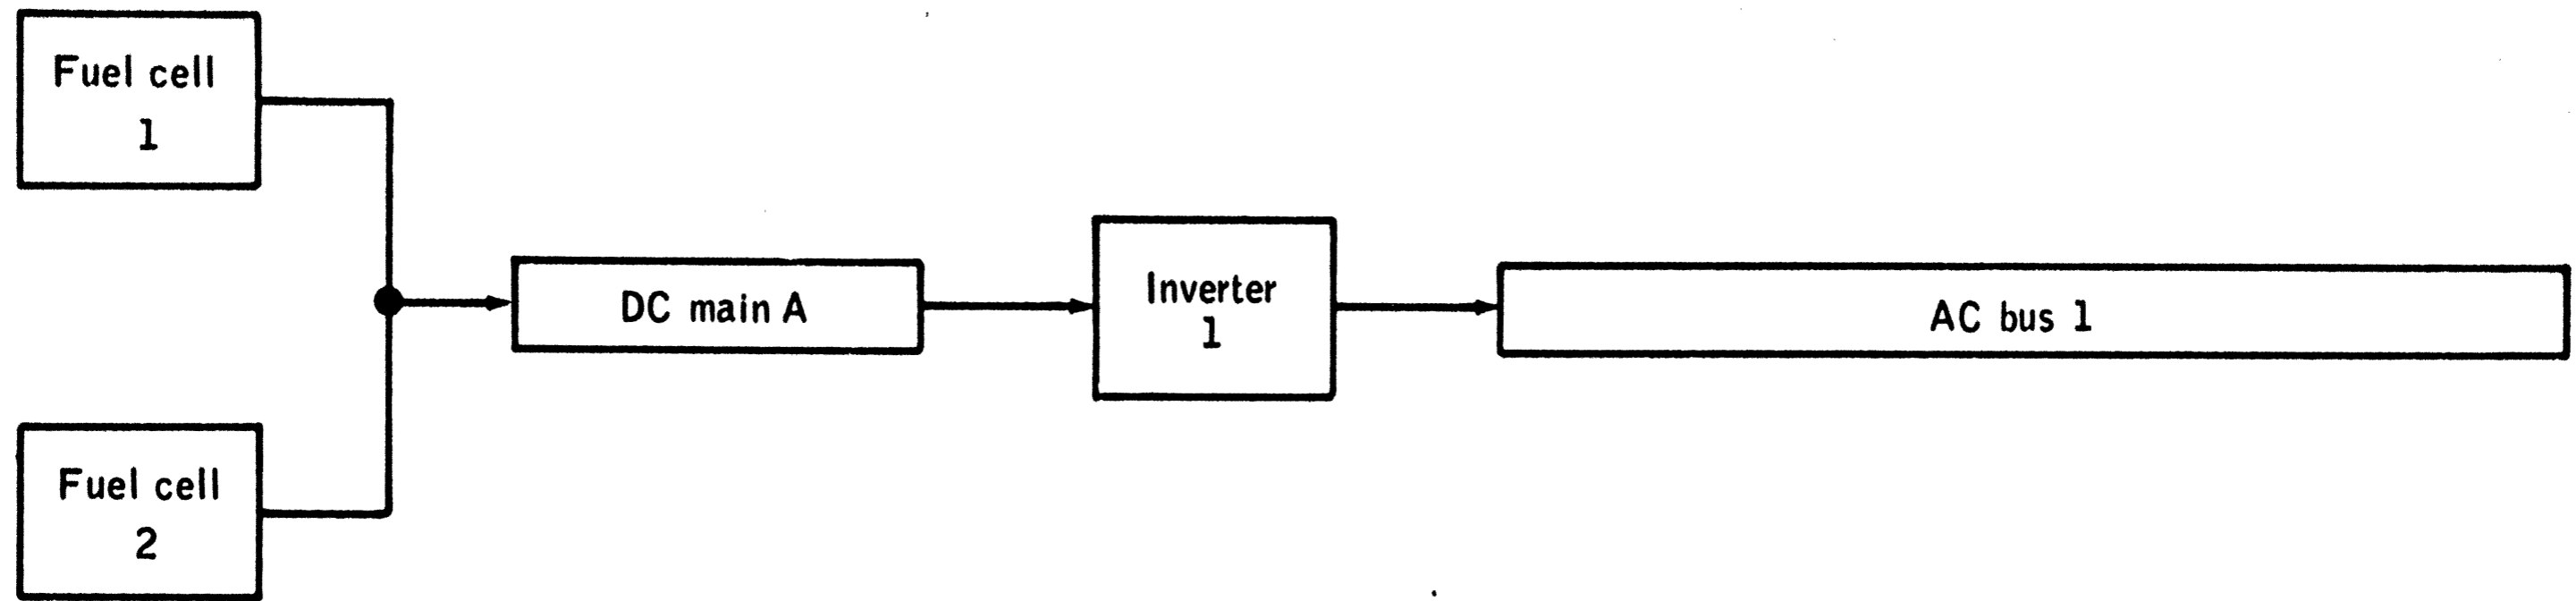
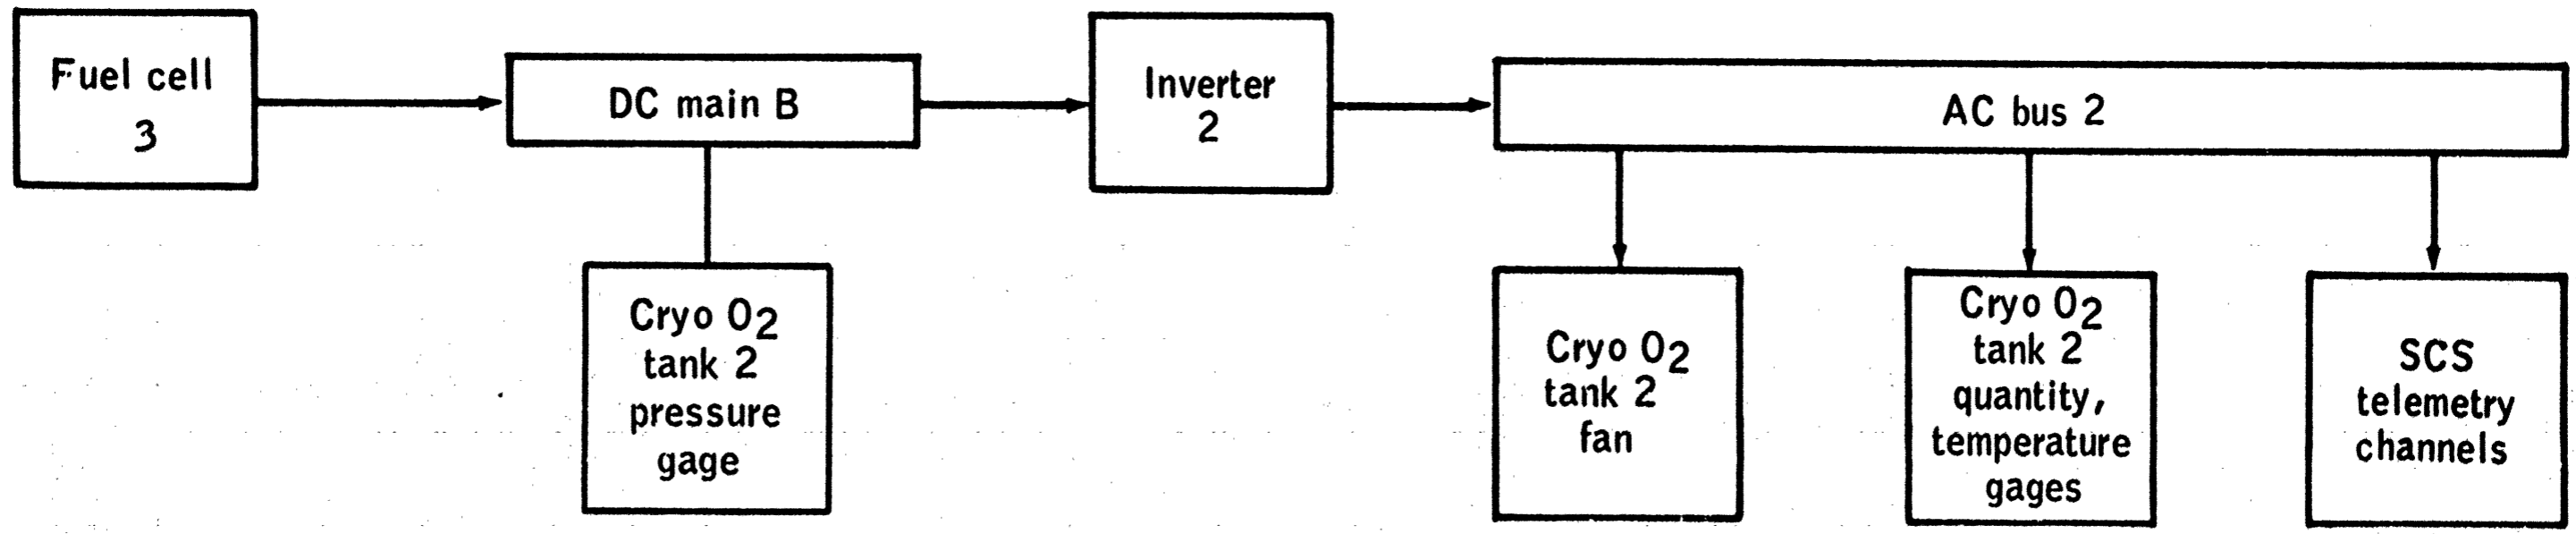
Figure 4-12.- Electrical configuration at 55:54:53 g.e.t.
