THE APOLLO 13 ACCIDENT

HEARINGS
BEFORE THE
COMMITTEE ON
SCIENCE AND ASTRONAUTICS
U.S. HOUSE OF REPRESENTATIVES
NINETY-FIRST CONGRESS
SECOND SESSION

JUNE 16, 1970

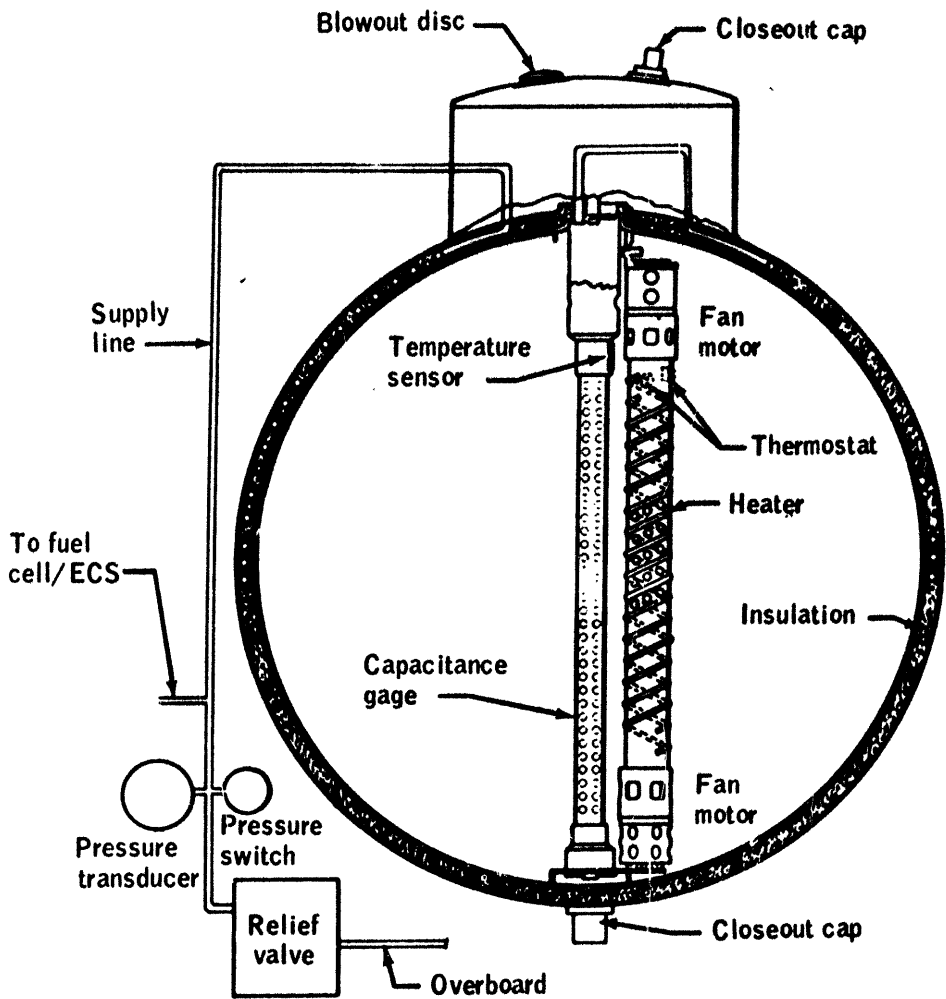
As the simplified drawing in Slide 8 indicates, each oxygen tank has an outer shell and an inner shell, arranged to provide a vacuum space to reduce heat leak, and a dome enclosing paths into the tank for transmission of fluids, and electrical power and signals.

The space between the shells and the space in the dome are filled with insulating materials. Mounted in the tank are two tubular assemblies. One, called the heater tube, contains two thermostatically protected heater coils and two small fans driven by 1800 RPM motors to stir the tank contents. The other assembly, called the quantity probe, consists of a cylindrical capacitance gage used to measure electrically the quantity of fluid in the tank. The inner cylinder of this probe is connected through the top of the tank to a fill line from the exterior of the SM and serves both as a fill and drain tube and as one plate of the capacitance gage. In addition, a temperature sensor is mounted on the outside of the quantity probe near the head. Wiring for the quantity gage, the temperature sensor, the fan motors, and the heaters passes through the head of the quantity probe, through a conduit in the dome and to a connector to the appropriate external circuits in the CSM. The routing of wires and lines from the tank through the dome is shown in Slide 9.

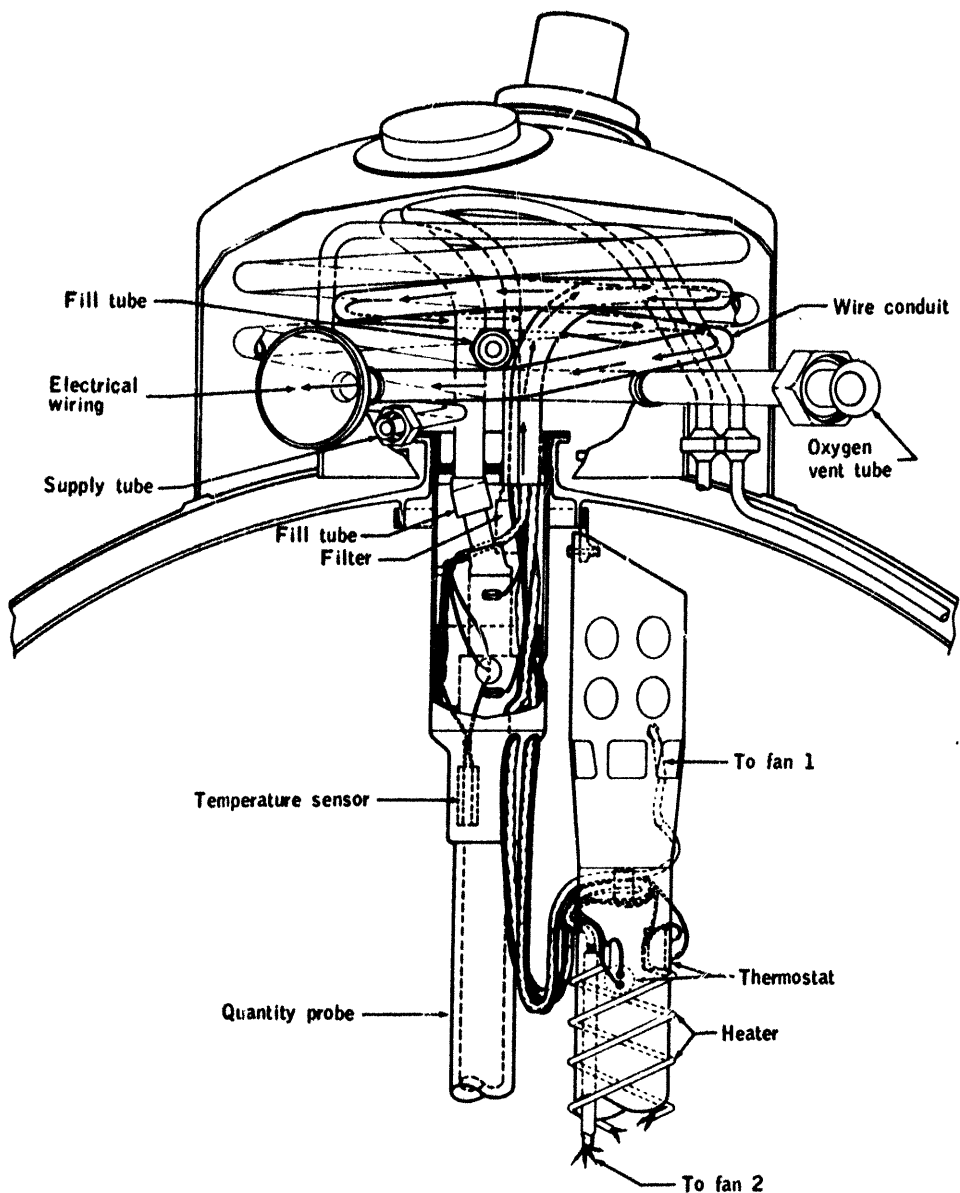
Slide 9

The oxygen tank, as designed, contained materials, which if ignited will burn in supercritical oxygen. These include Teflon, used, for example, to insulate the wiring, and aluminum.

As shown in Slide 9, each heater coil is protected with a thermostatic switch, mounted on the heater tube, which is intended to open the heater circuit when it senses a temperature of 80° F. As I will point out later in tracing the Board's conclusions as to the cause of the accident, when the heaters were powered from a 65 volt DC supply at KSC during an improvised detanking procedure, these thermostatic switches, because they were rated at only 30 V DC, could not prevent an overheating condition of the heaters and the associated wiring. Tests conducted for the Board indicate that the heater tube assembly was probably heated to a temperature of as much as 1000° F during this detanking procedure.

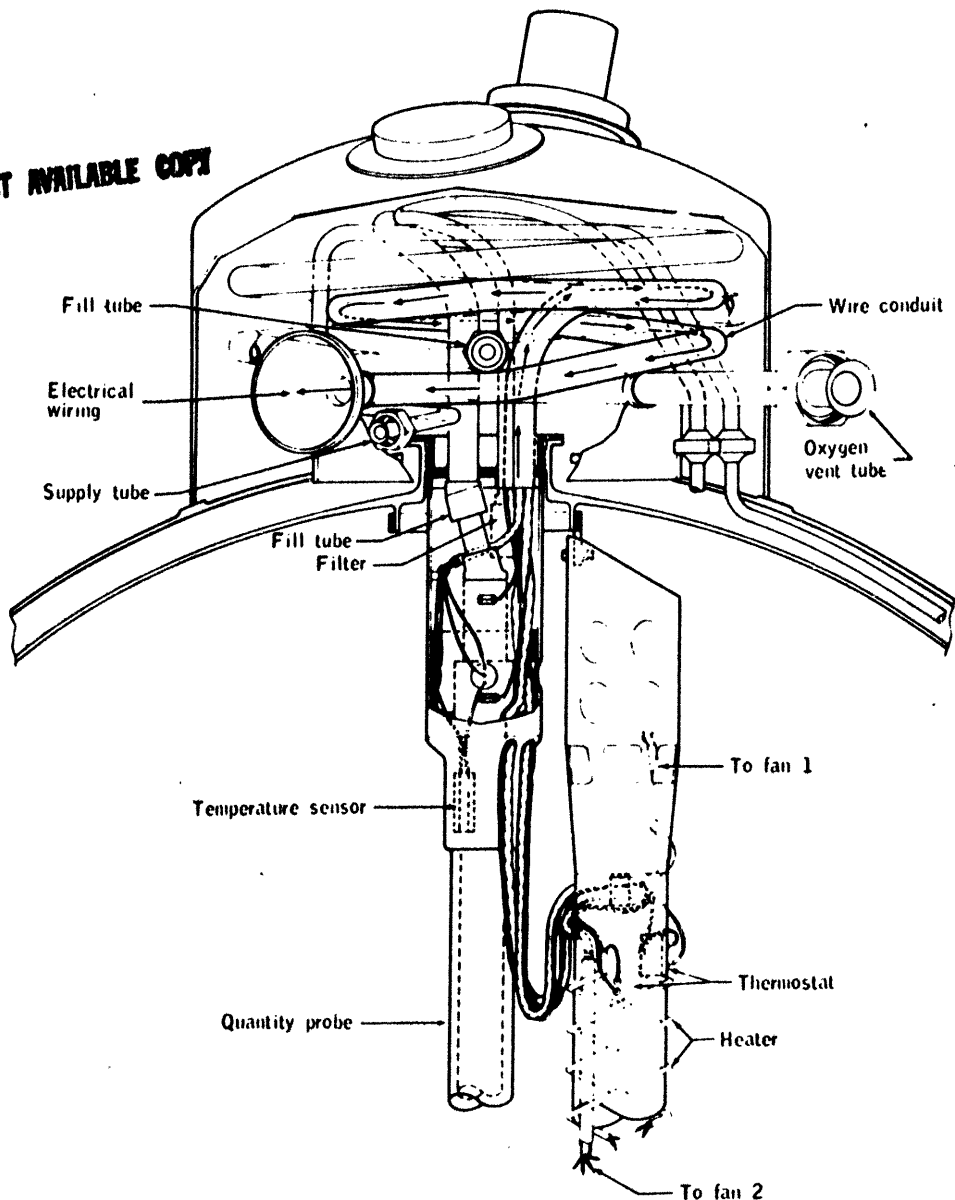
Slide 9

I believe the next slide (slide 9) shows a little more detail on the area where the problem at least got to its worst stage.

A temperature rise of not too much would make it fail at the 1,000 pounds per square inch pressure it was then experiencing. Probably the penetration cap came out at that time.

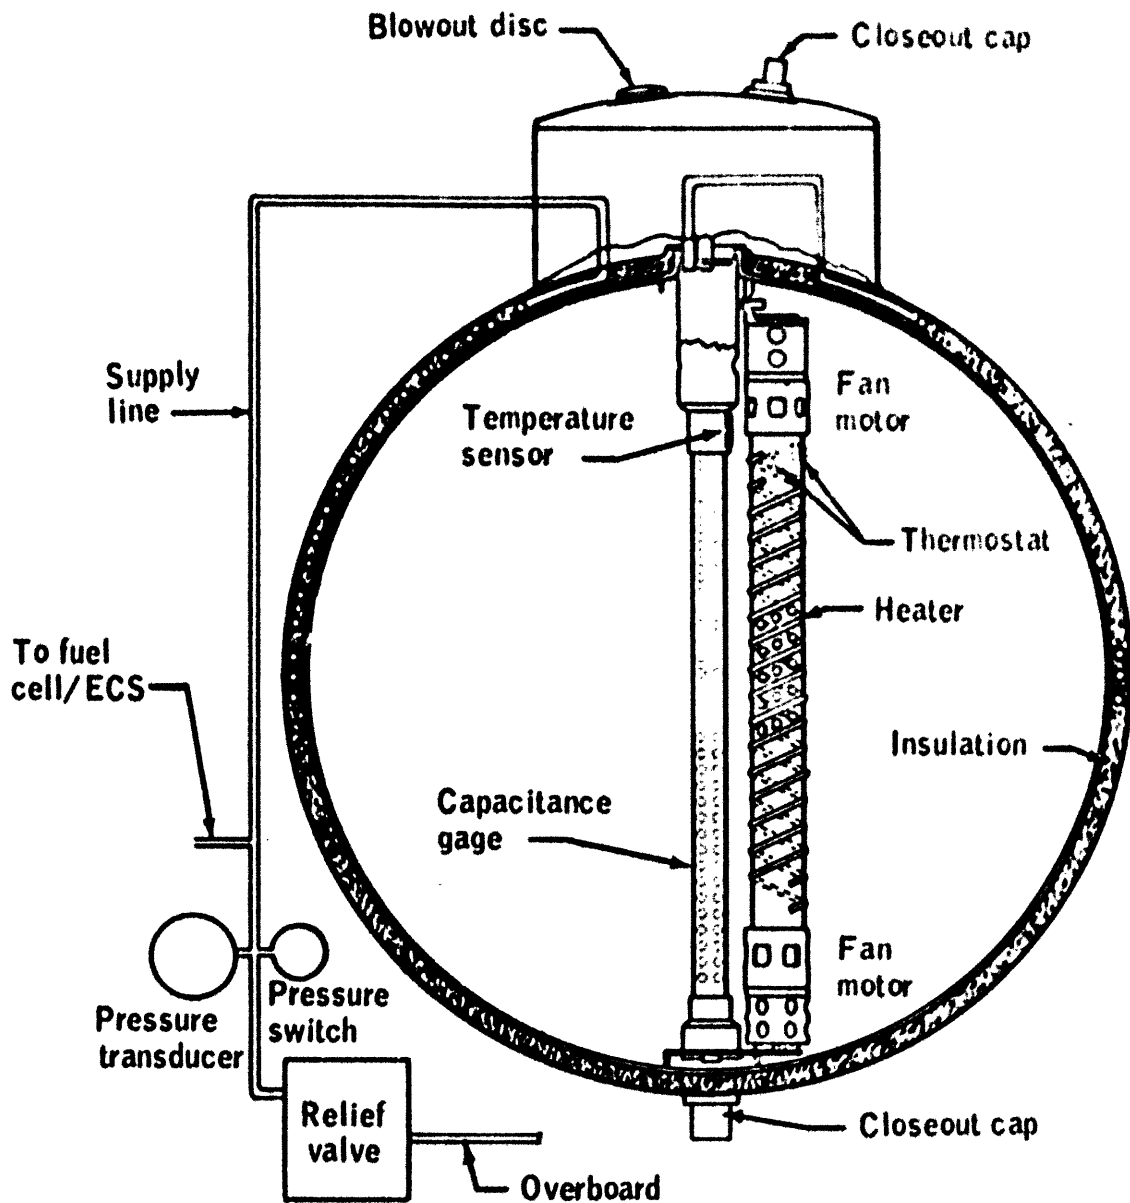
Figure 4-1.- Oxygen tank no. 2 internal components.

As the simplified drawing in figure 4-1 indicates, each oxygen tank has an outer shell and an inner shell, arranged to provide a vacuum space to reduce heat leak, and a dome enclosing paths into the tank for transmission of fluids and electrical power and signals. The space between the shells and the space in the dome are filled with insulating materials. Mounted in the tank are two tubular assemblies. One, called the heater tube, contains two thermostatically protected heater coils and two small fans driven by 1800 rpm motors to stir the tank contents. The other, called the quantity probe, consists of an upper section which supports a cylindrical capacitance gage used to measure electrically the quantity of fluid in the tank. The inner cylinder of this probe serves both as a fill and drain tube and as one plate of the capacitance gage. In addition, a temperature sensor is mounted on the outside of the quantity probe near the head. Wiring for the gage, the temperature sensor, the fan motors, and the heaters passes through the head of the quantity probe to a conduit in the dome. From there the wiring runs to a connector which ties it electrically to the appropriate external circuits in the CSM. The routing of wiring and lines from the tank through the dome is shown in figure 4-2.

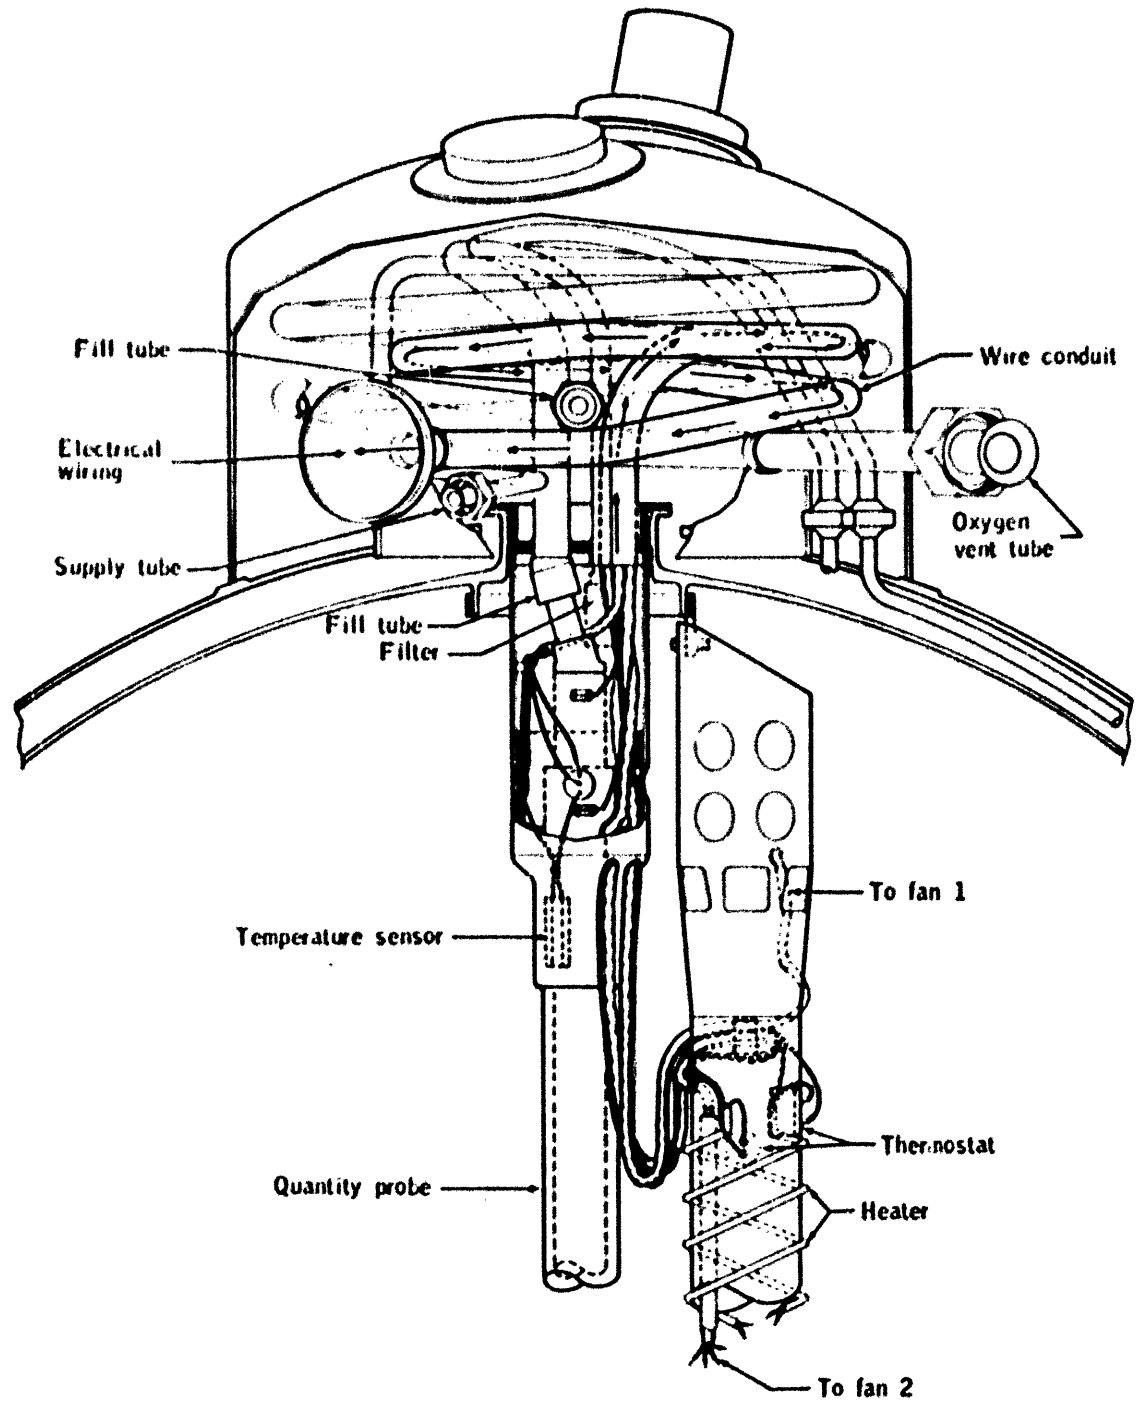
Figure 4-2.- Oxygen tank wiring and lines.

As shown in figure 4-2, the fill line from the exterior of the SM enters the oxygen tank and connects to the inner cylinder of the capacitance gage through a coupling of two Teflon adapters or sleeves and a short length of Inconel tubing. The dimensions and tolerances selected are such that if "worst case" variations in an actual system were to occur, the coupling might not reach from the fill line to the gage cylinder (fig. 4-3). Thus, the variations might be such that a very loose fit would result.

As noted earlier in this chapter, and shown in figure 4-2, each heater is protected with a thermostatic switch, mounted on the heater tube, which is intended to open the heater circuit when it senses a temperature of 80° F. In tests conducted at MSC since the accident, however, it was found that the switches failed to open when the heaters were powered from a 65 V dc supply similar to the power used at KSC during the detanking sequence. Subsequent investigations have shown that the thermostatic switches used, while rated as satisfactory for the 28 V dc spacecraft power supply, could not open properly at 65 V dc. Qualification and test procedures for the heater assemblies and switches do not at any time test the capability of the switches to open while under full current conditions. A review of the voltage recordings made during the detanking at KSC indicates that, in fact, the switches did not open when the temperature indication from within the tank rose past 80° F. Further tests have shown that the temperatures on the heater tube may have reached as much as 1000° F during the detanking. This temperature will cause serious damage to adjacent Teflon insulation, and such damage almost certainly occurred.

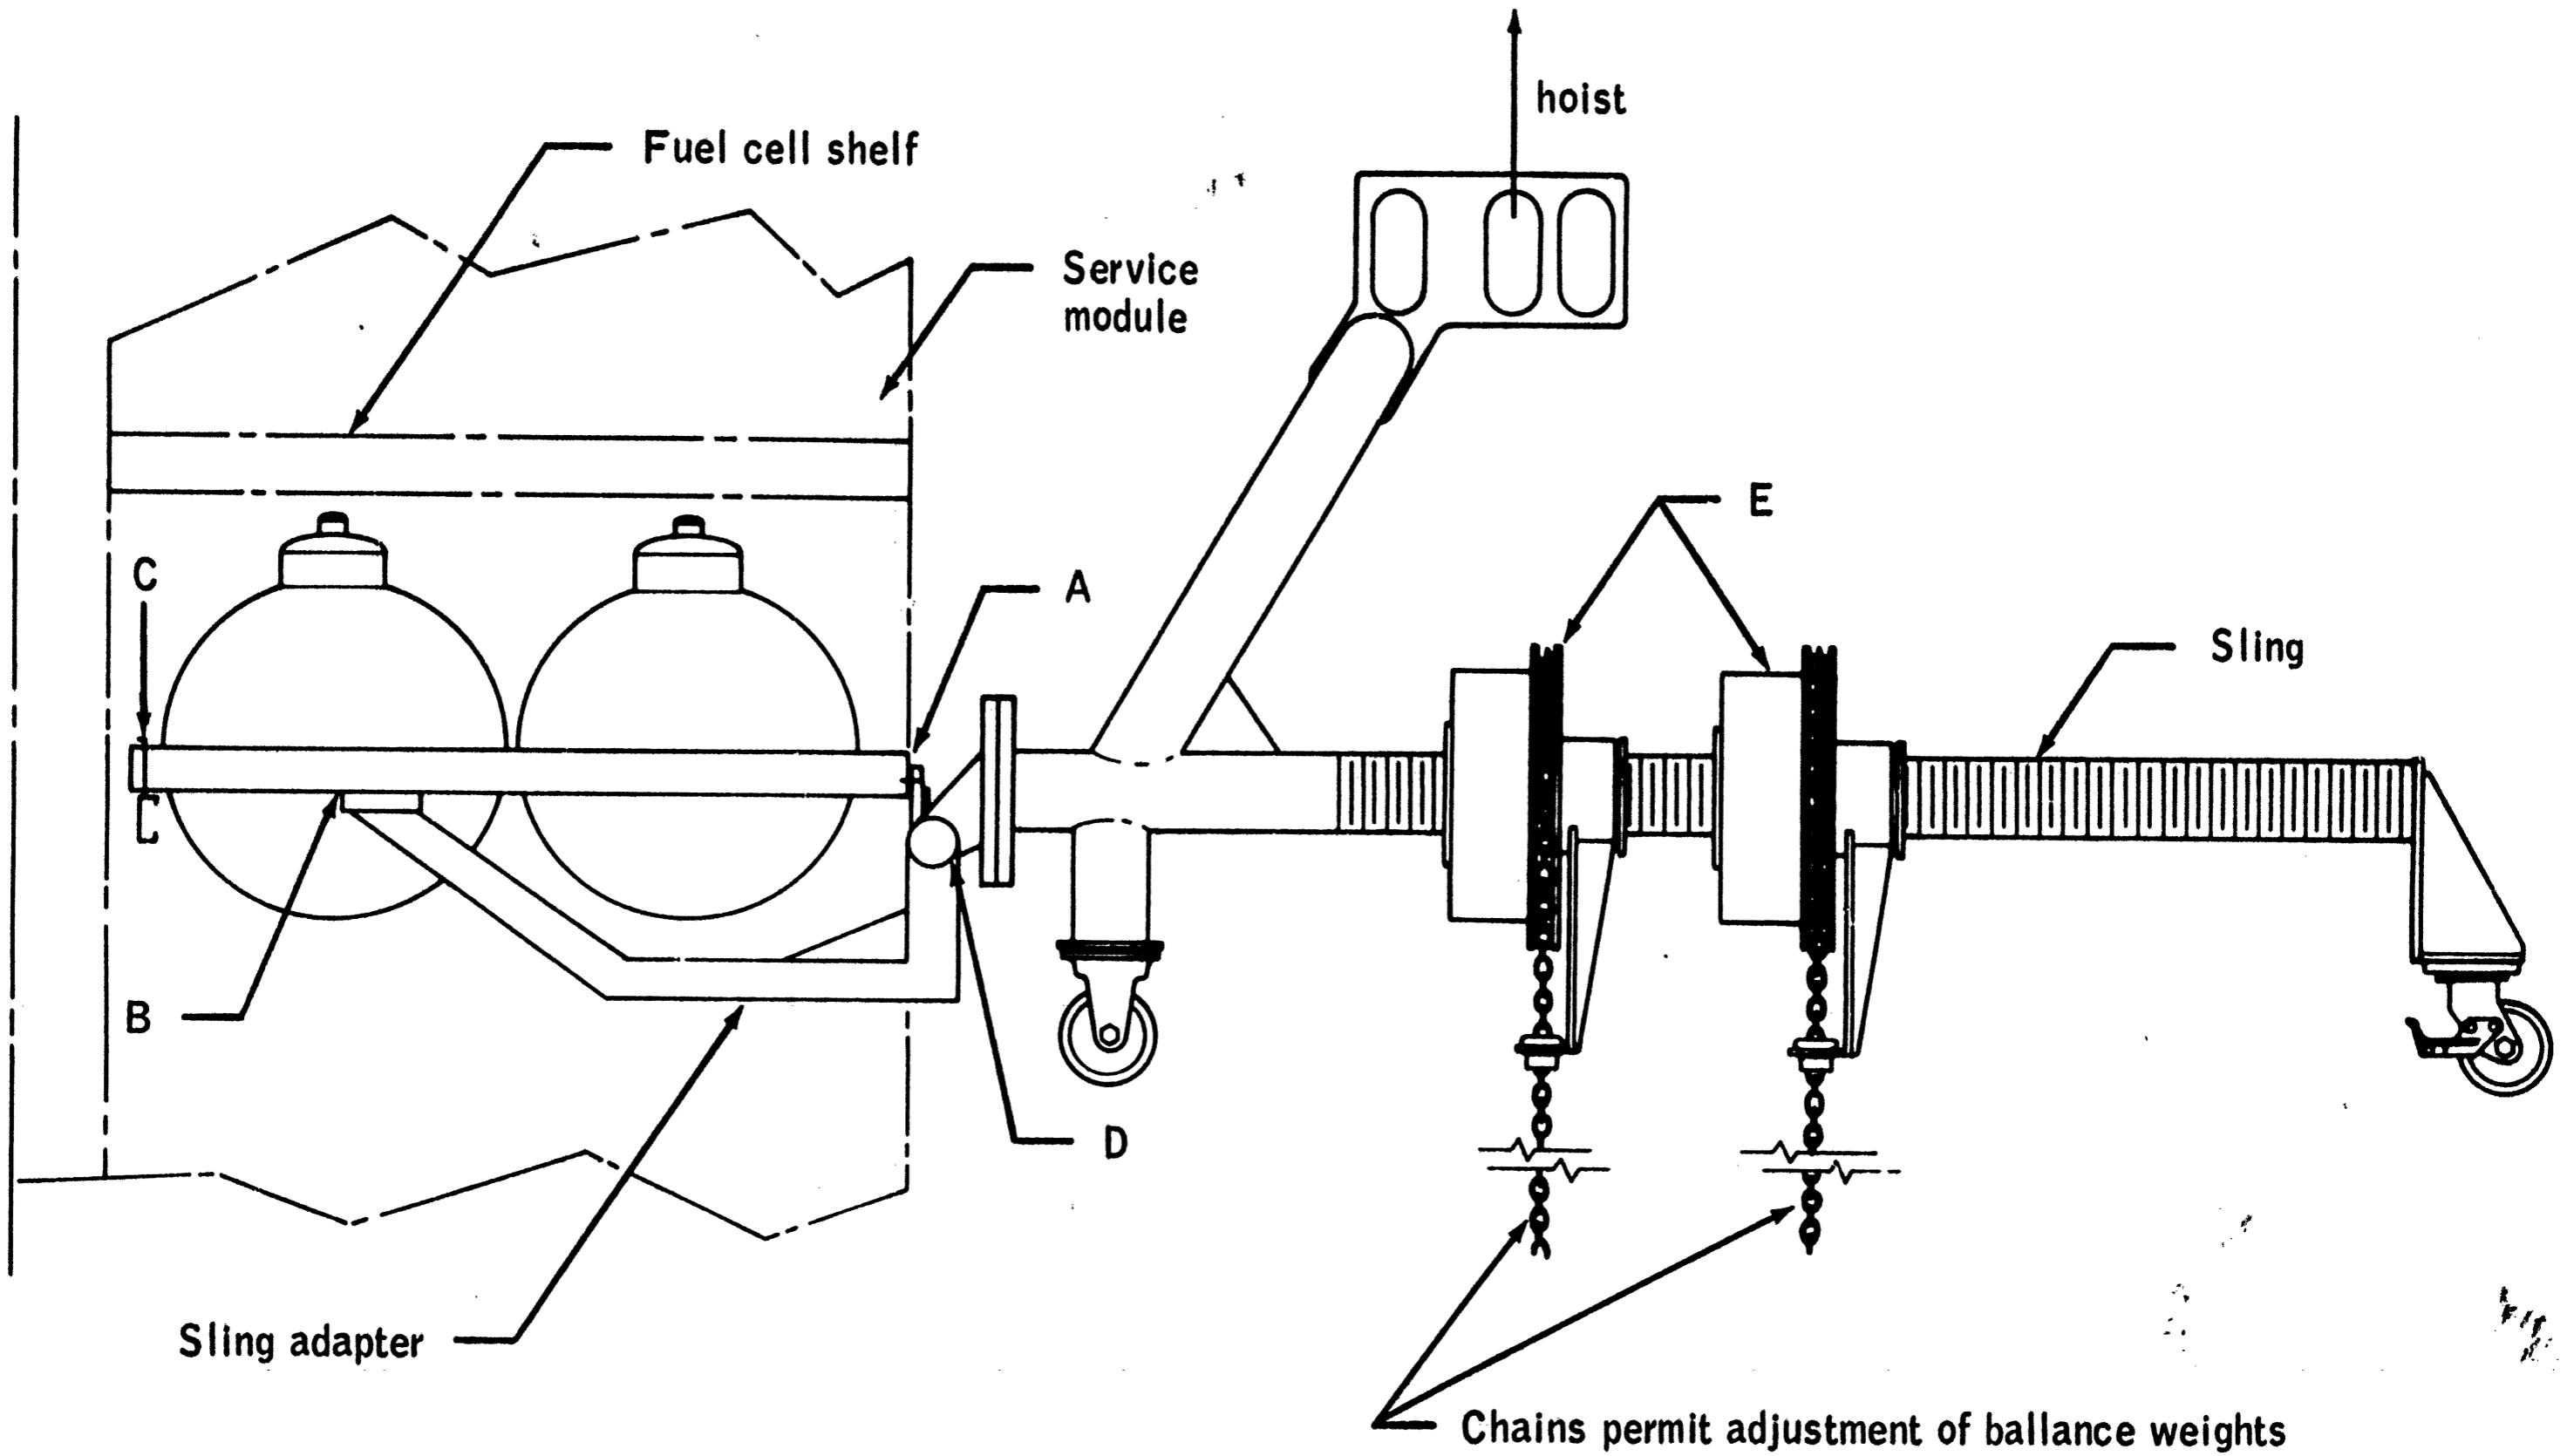
Figure 4-9.- Hoist and sling arrangement - oxygen shelf.

The oxygen shelf was removed in the manner shown in figure 4-9. After various lines and wires were disconnected and bolts which hold the shelf in the SM were removed, a fixture suspended from a crane was placed under the shelf and used to lift the shelf and extract it from bay 4. One shelf bolt was mistakenly left in place during the initial attempt to remove the shelf; and as a consequence, after the front of the shelf was raised about 2 inches, the fixture broke, allowing the shelf to drop back into place. Photographs of the underside of the fuel cell shelf in SM 106 indicate that the closeout cap on the dome of oxygen tank no. 2 may have struck the underside of that shelf during this incident. At the time, however, it was believed that the oxygen shelf had simply dropped back into place and an analysis was performed to calculate the forces resulting from a drop of 2 inches. It now seems likely that the shelf was first accelerated upward and then dropped.

The remaining bolt was then removed, the incident recorded, and the oxygen shelf was removed without further difficulty. Following removal, the oxygen shelf was retested to check shelf integrity, including proof-pressure tests, leak tests, and functional tests of pressure transducers and switches, thermal switches, and vac-ion pumps. No cryogenic testing was conducted. Visual inspection revealed no problem. These tests would have disclosed external leakage or serious internal malfunctions of most types, but would not disclose fill line leakage within oxygen tank no. 2. Further calculations and tests conducted during this investigation, however, have indicated that the forces experienced by the shelf were probably close to those originally

calculated assuming a 2-inch drop only. The probability of tank damage from this incident, therefore, is now considered to be rather low, although it is possible that a loosely fitting fill tube could have been displaced by the event.

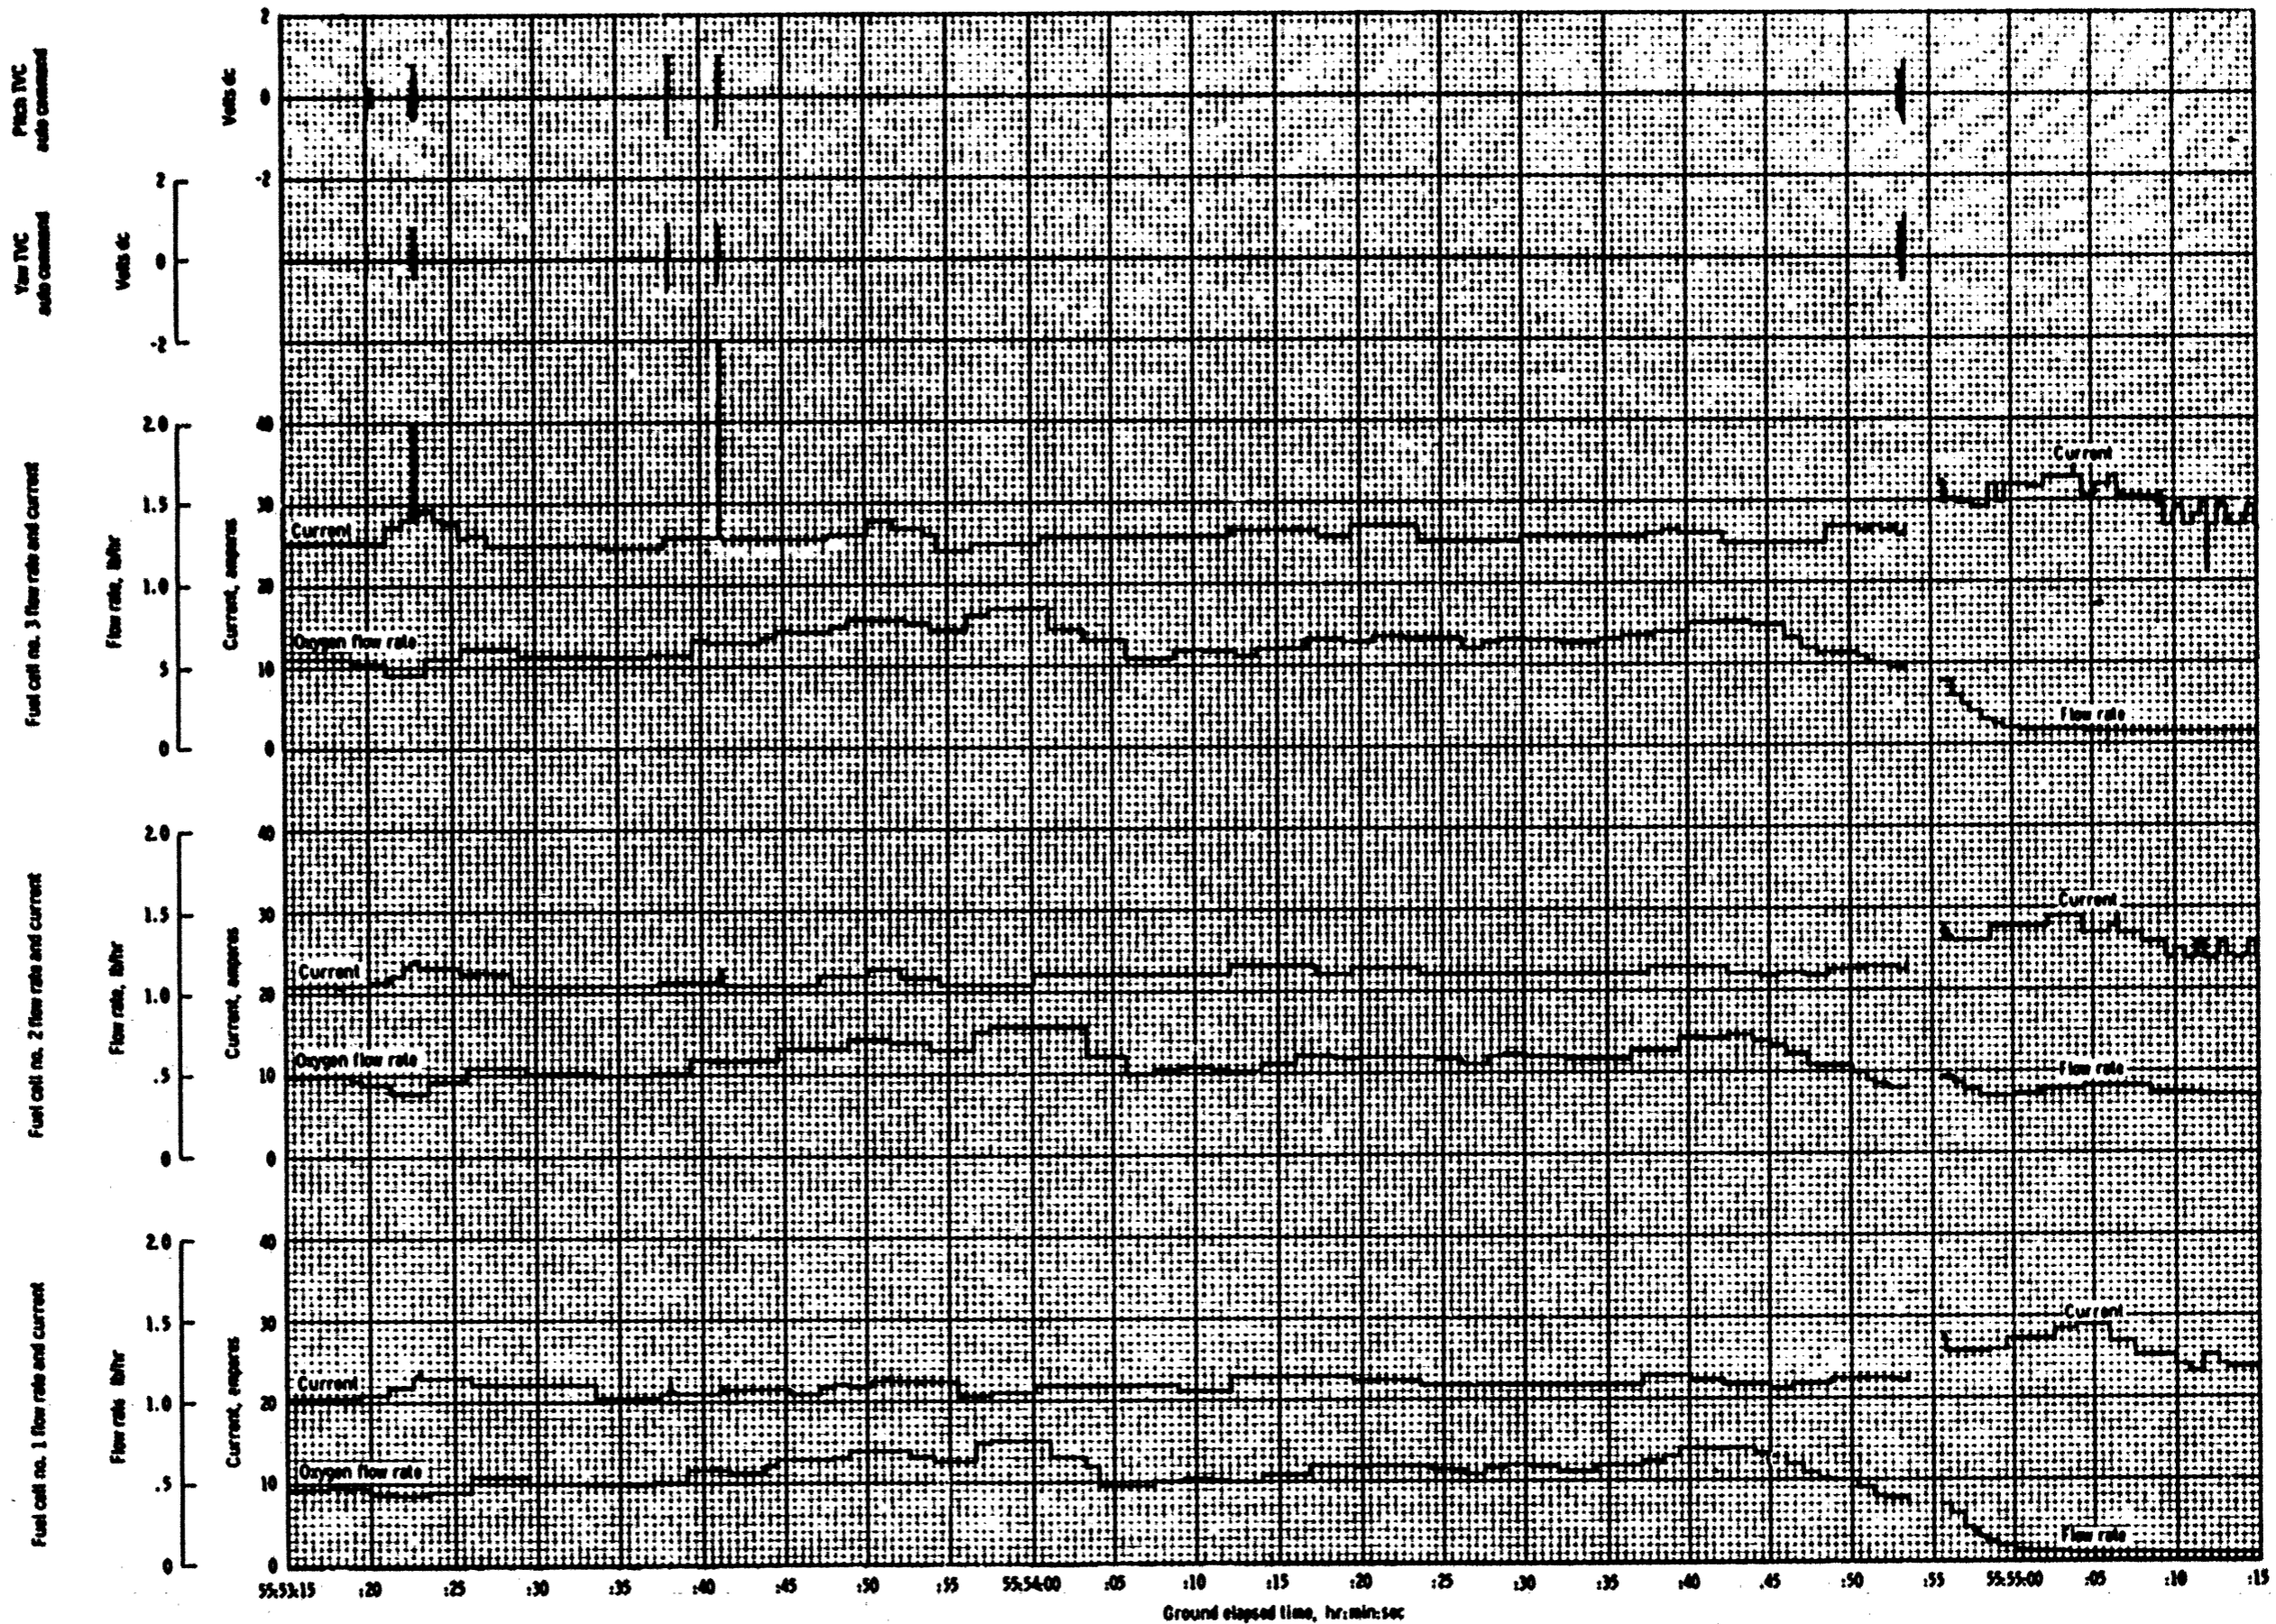
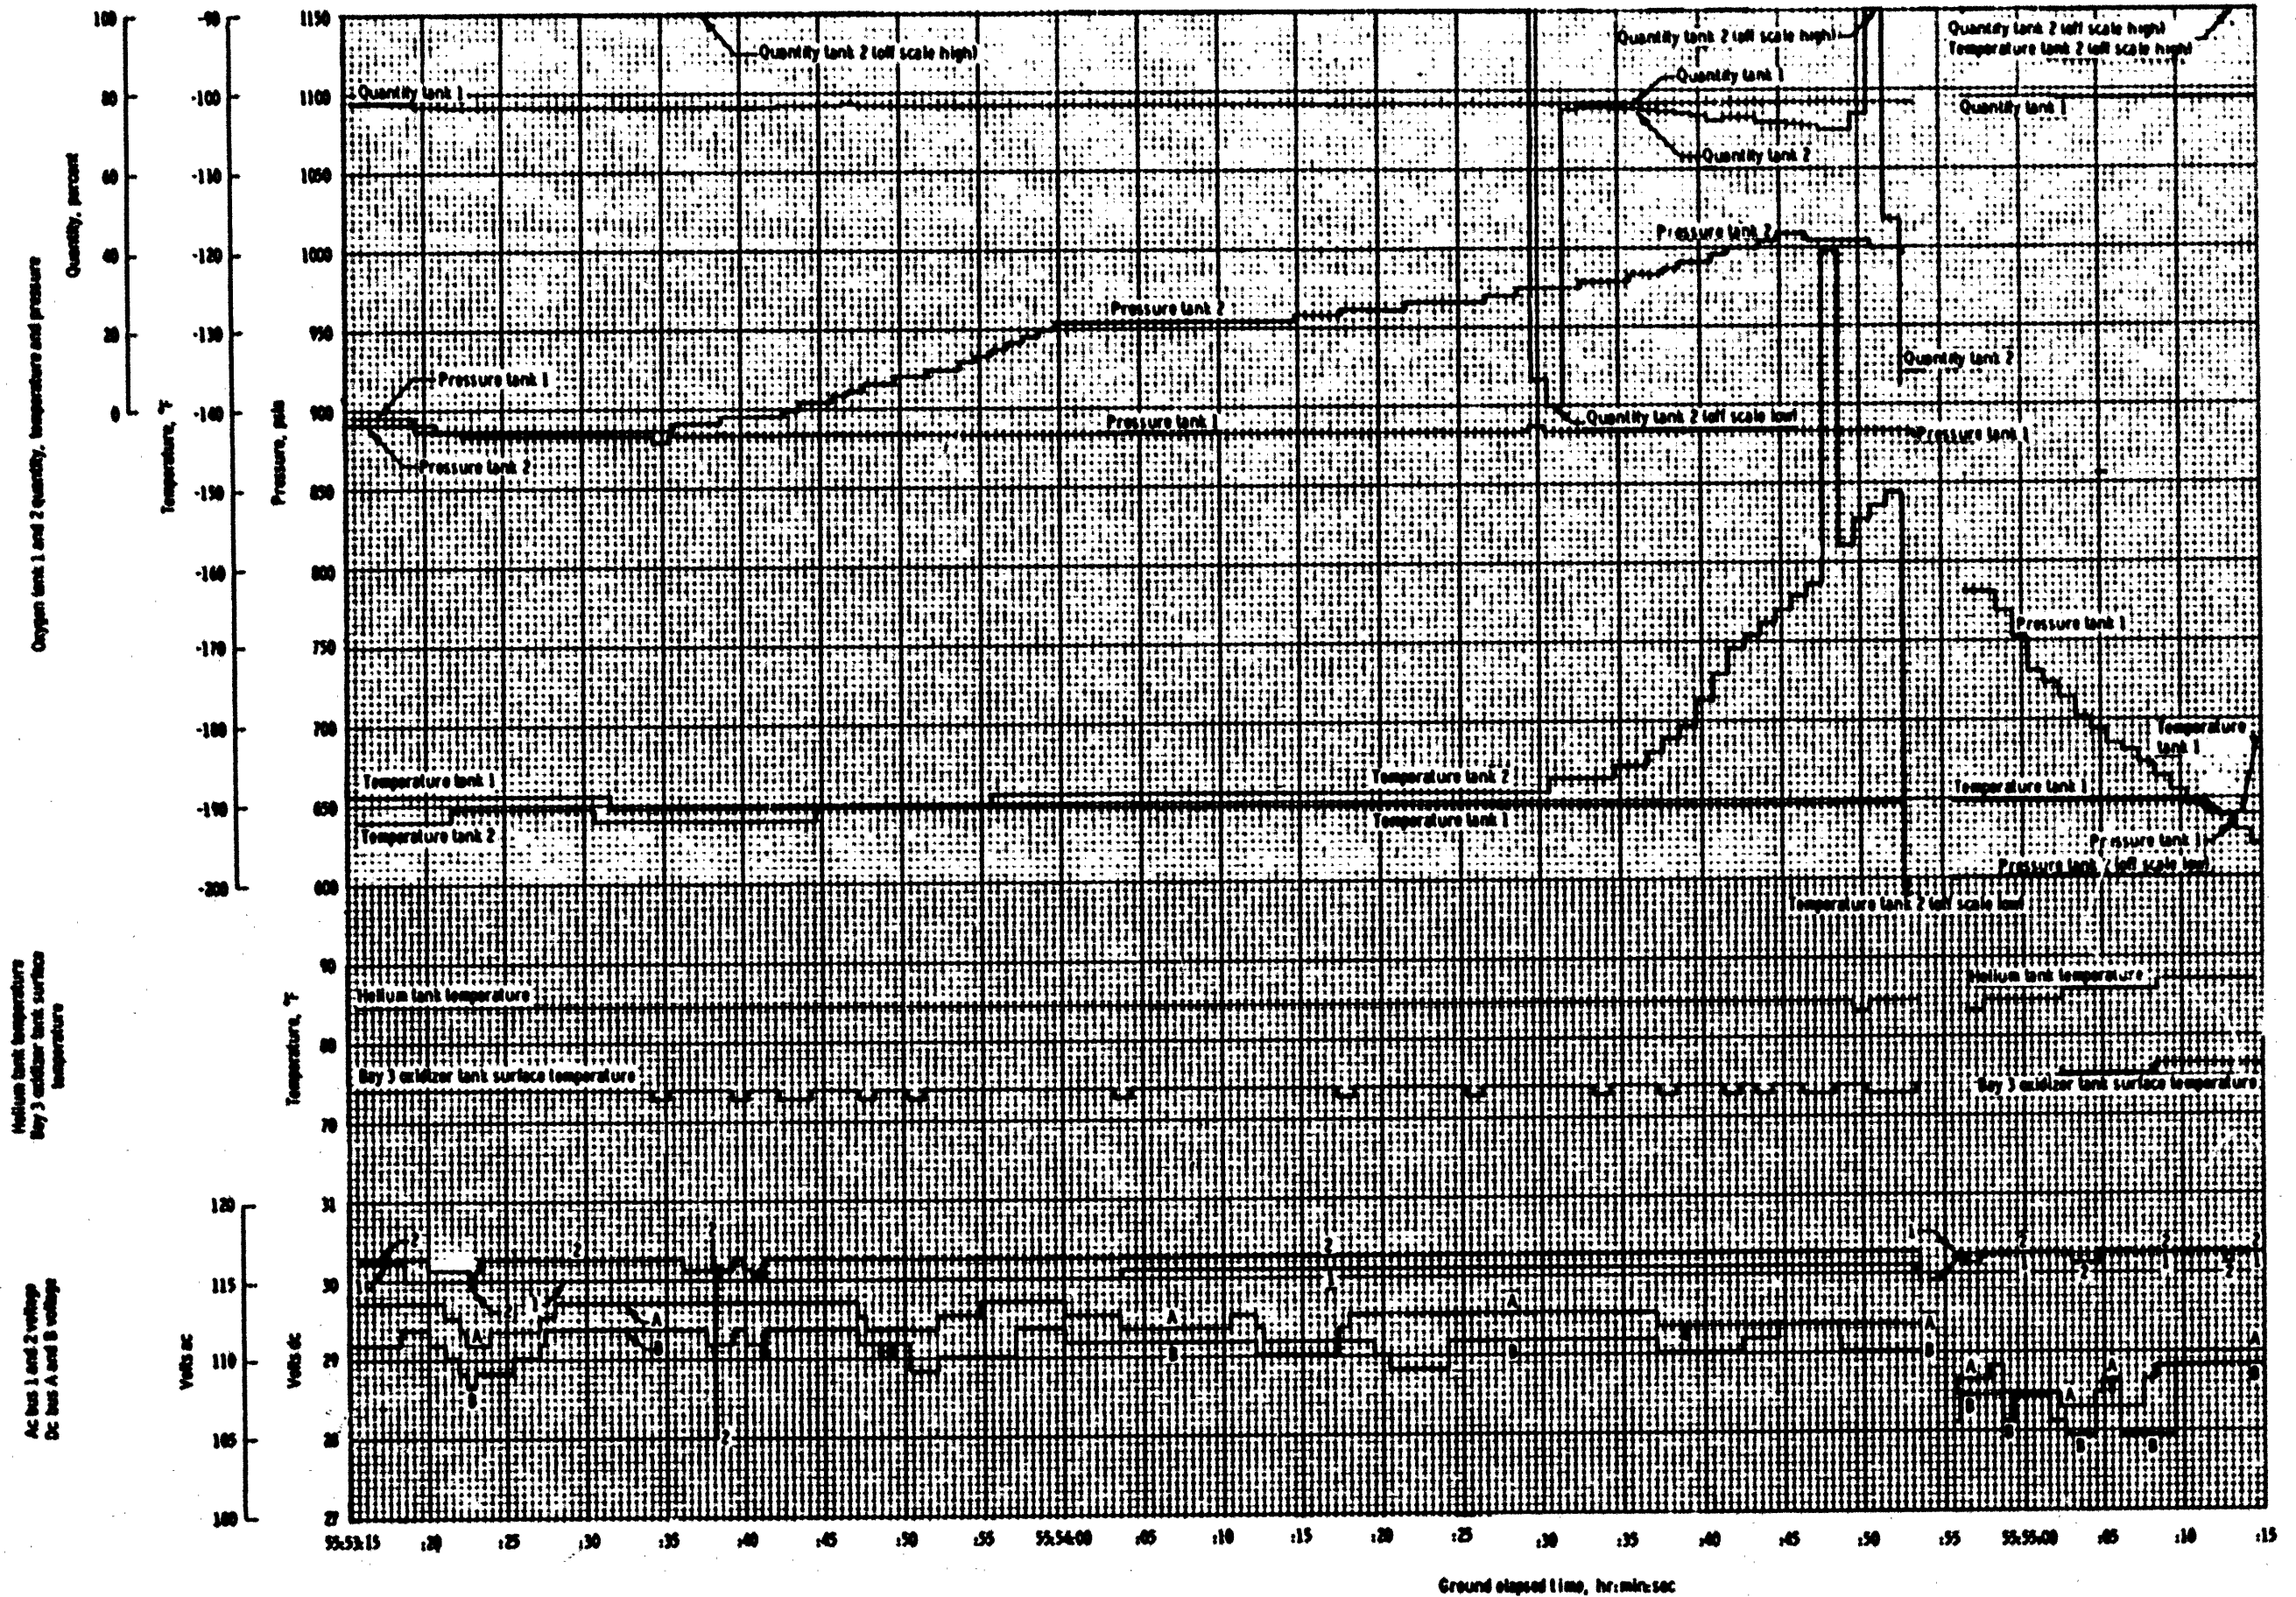
Figure 4-10.- Telemetry record.

The various telemetered parameters of primary interest are shown in figure 4-10 and listed in table 4-11.
